Joint Council on Aging Aircraft/
Joint Group on Pollution Prevention

JCAA/JG-PP Lead-Free Solder Project: Vibration Test

Tom Woodrow
Boeing Phantom Works
Seattle, WA

IPC APEX
Anaheim, CA
February 5 - 10, 2006

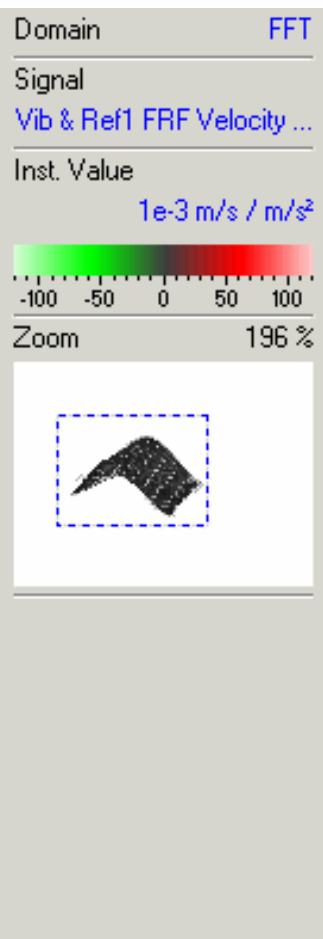
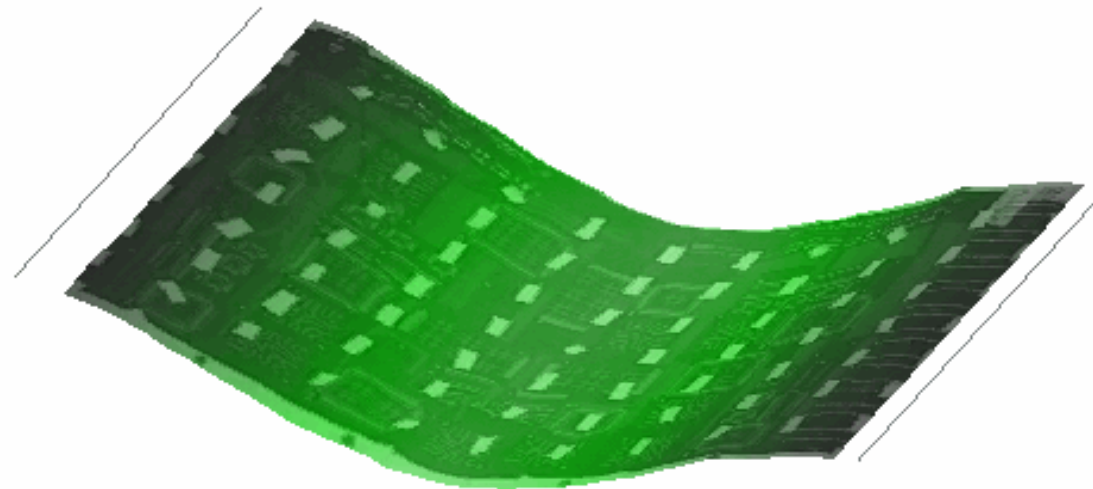
Operating Deflection Shape at 72 Hz

Boeing's prediction of first resonance was 82 Hz

It is very important to understand that during vibration testing, the vibration environment at a given location on a test vehicle can be very different from the vibration environment at a different location on the same vehicle during the same test. This means that only identical components in identical locations on identical test vehicles can be directly compared. It also implies that the test solder must be used on one set of test vehicles and the control solder on a second set of test vehicles.

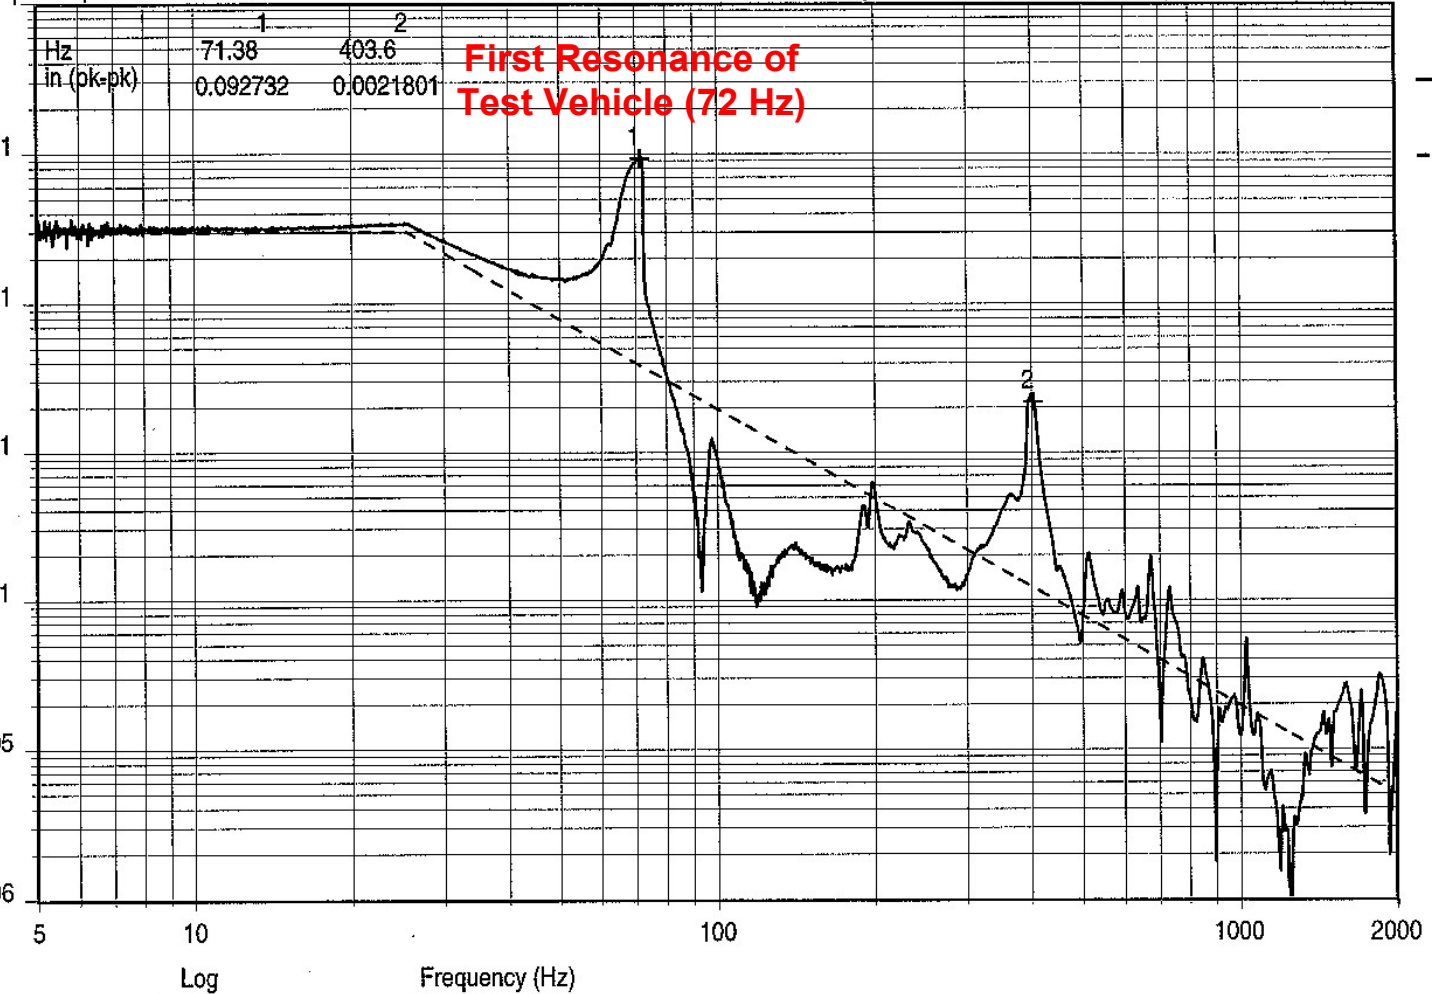
Displacement vs. Frequency

(the most displacement is at 72 Hz)

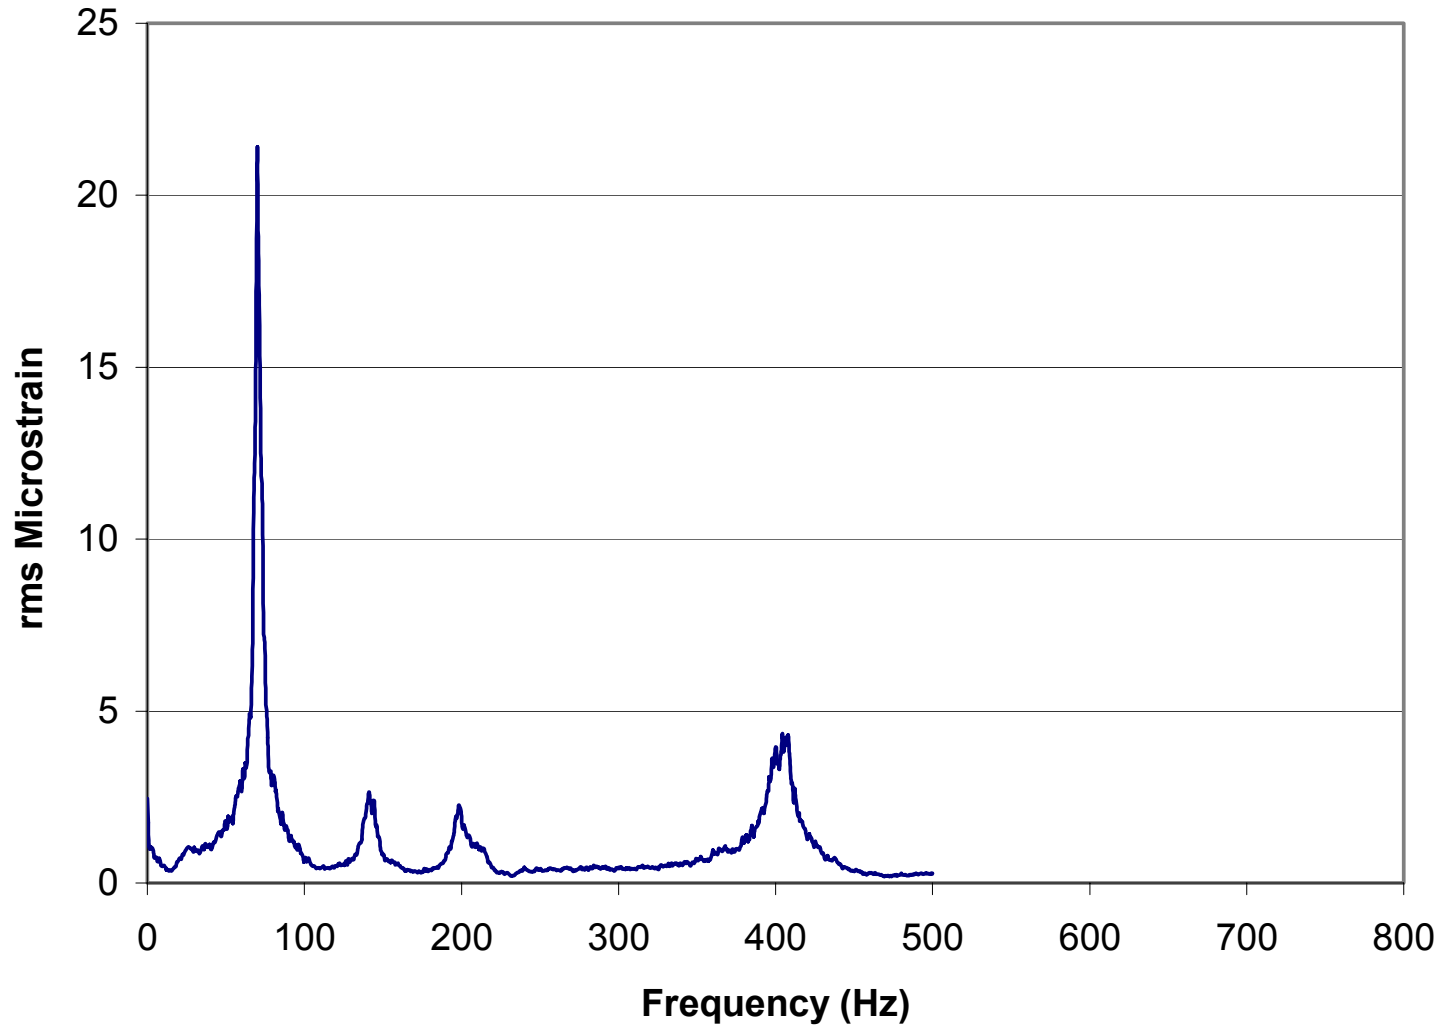
Strain vs. Frequency, 9.9 Grms

(the most strain is at 72 Hz)

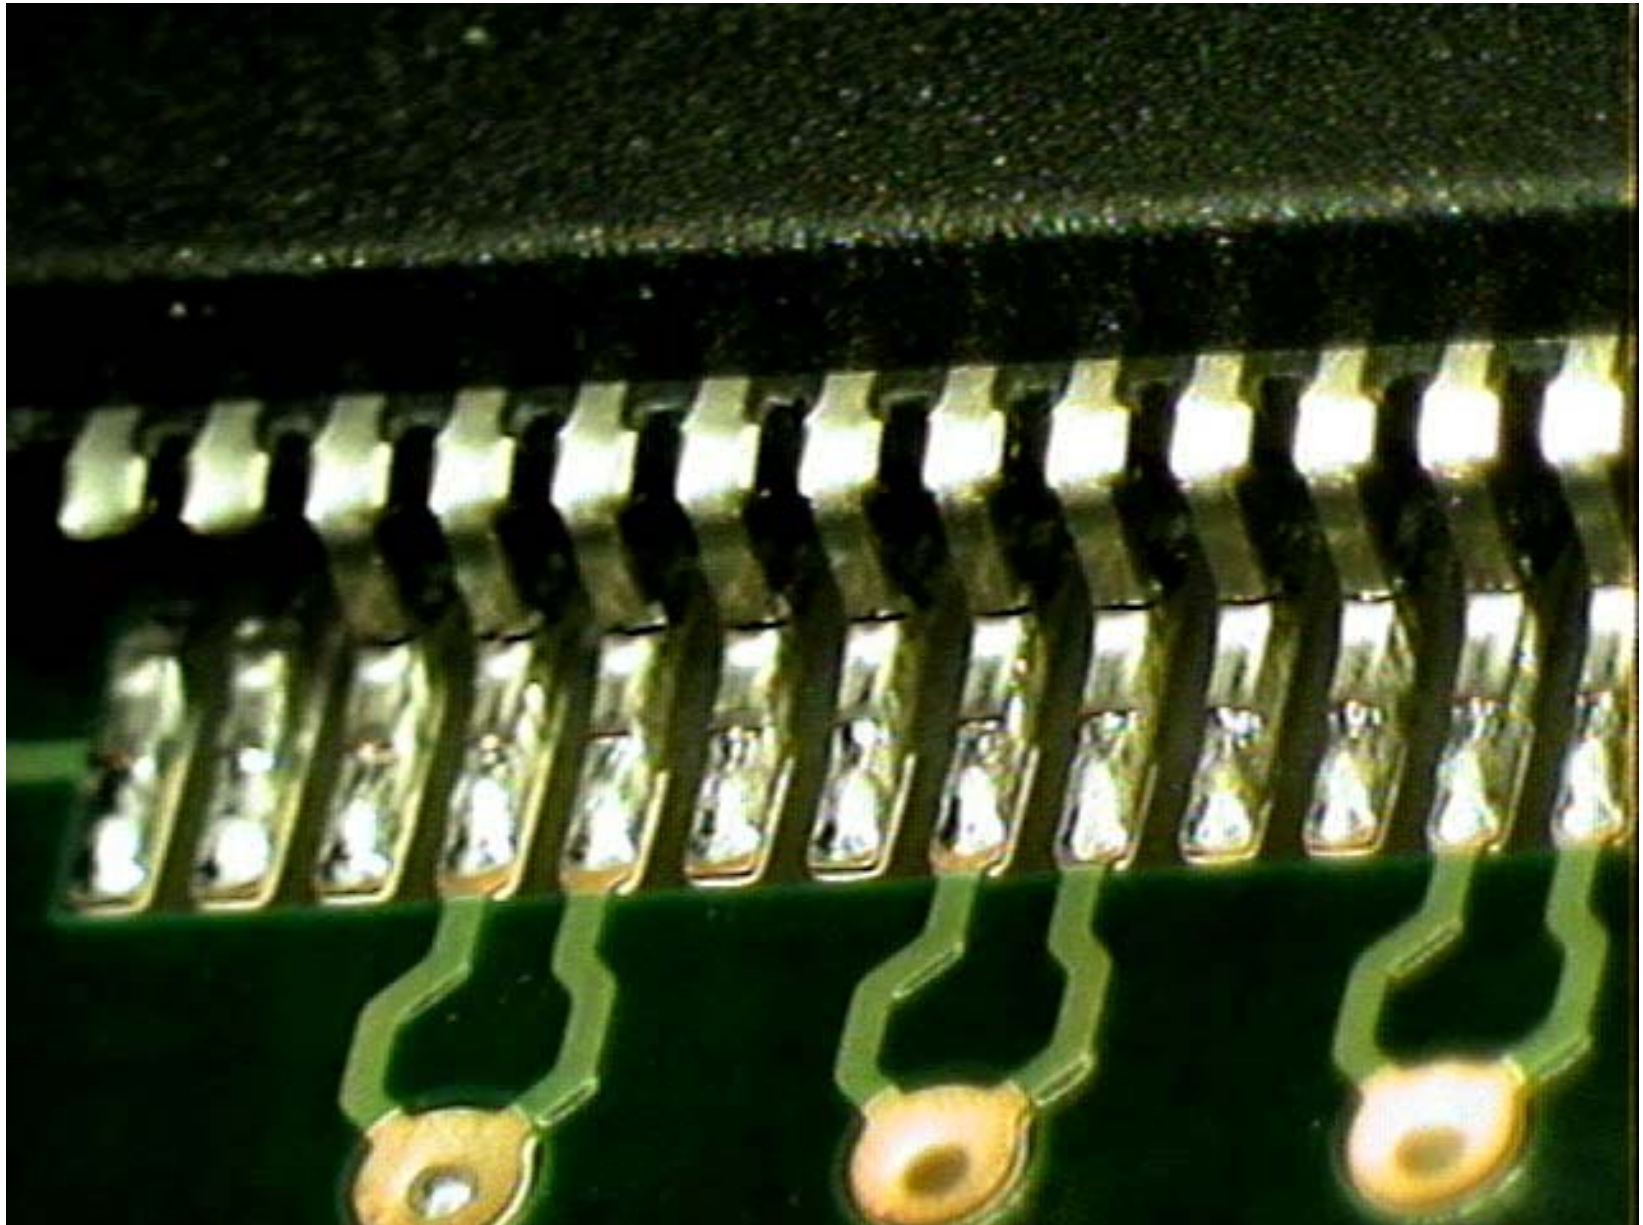
QFP's Had Missing and Broken Leads

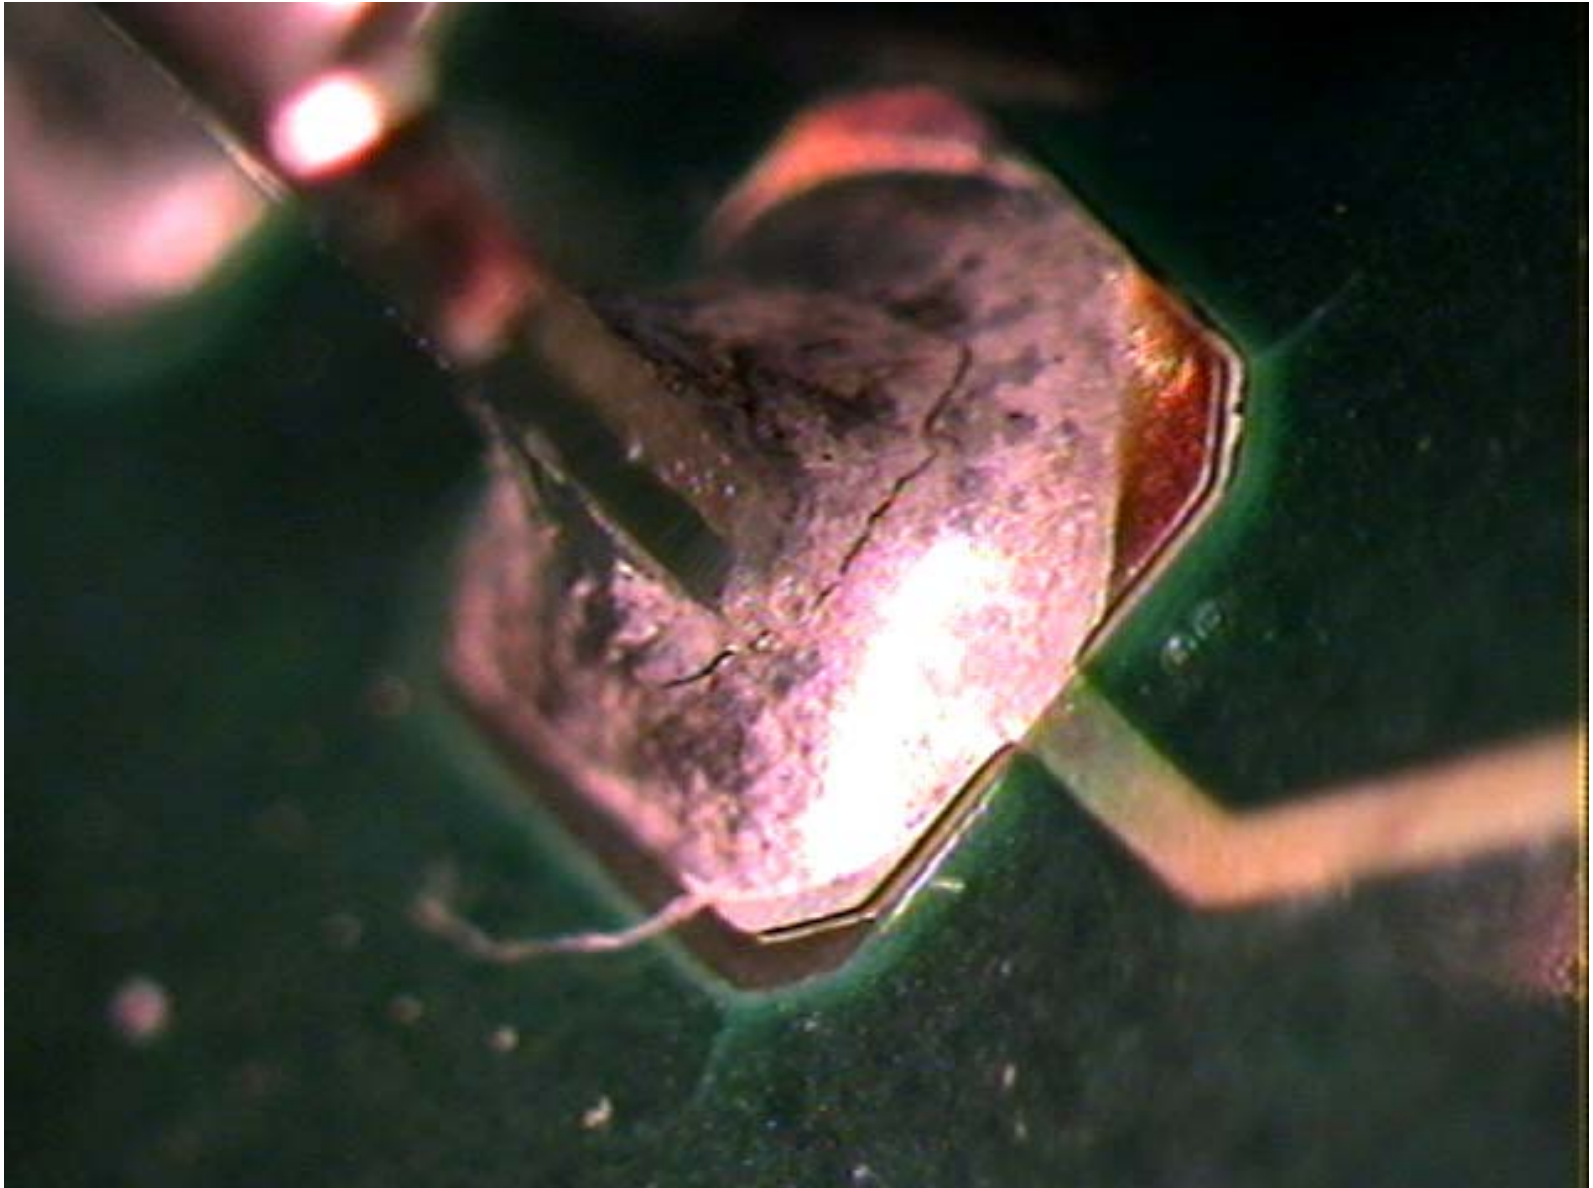
Typical DIP Failure

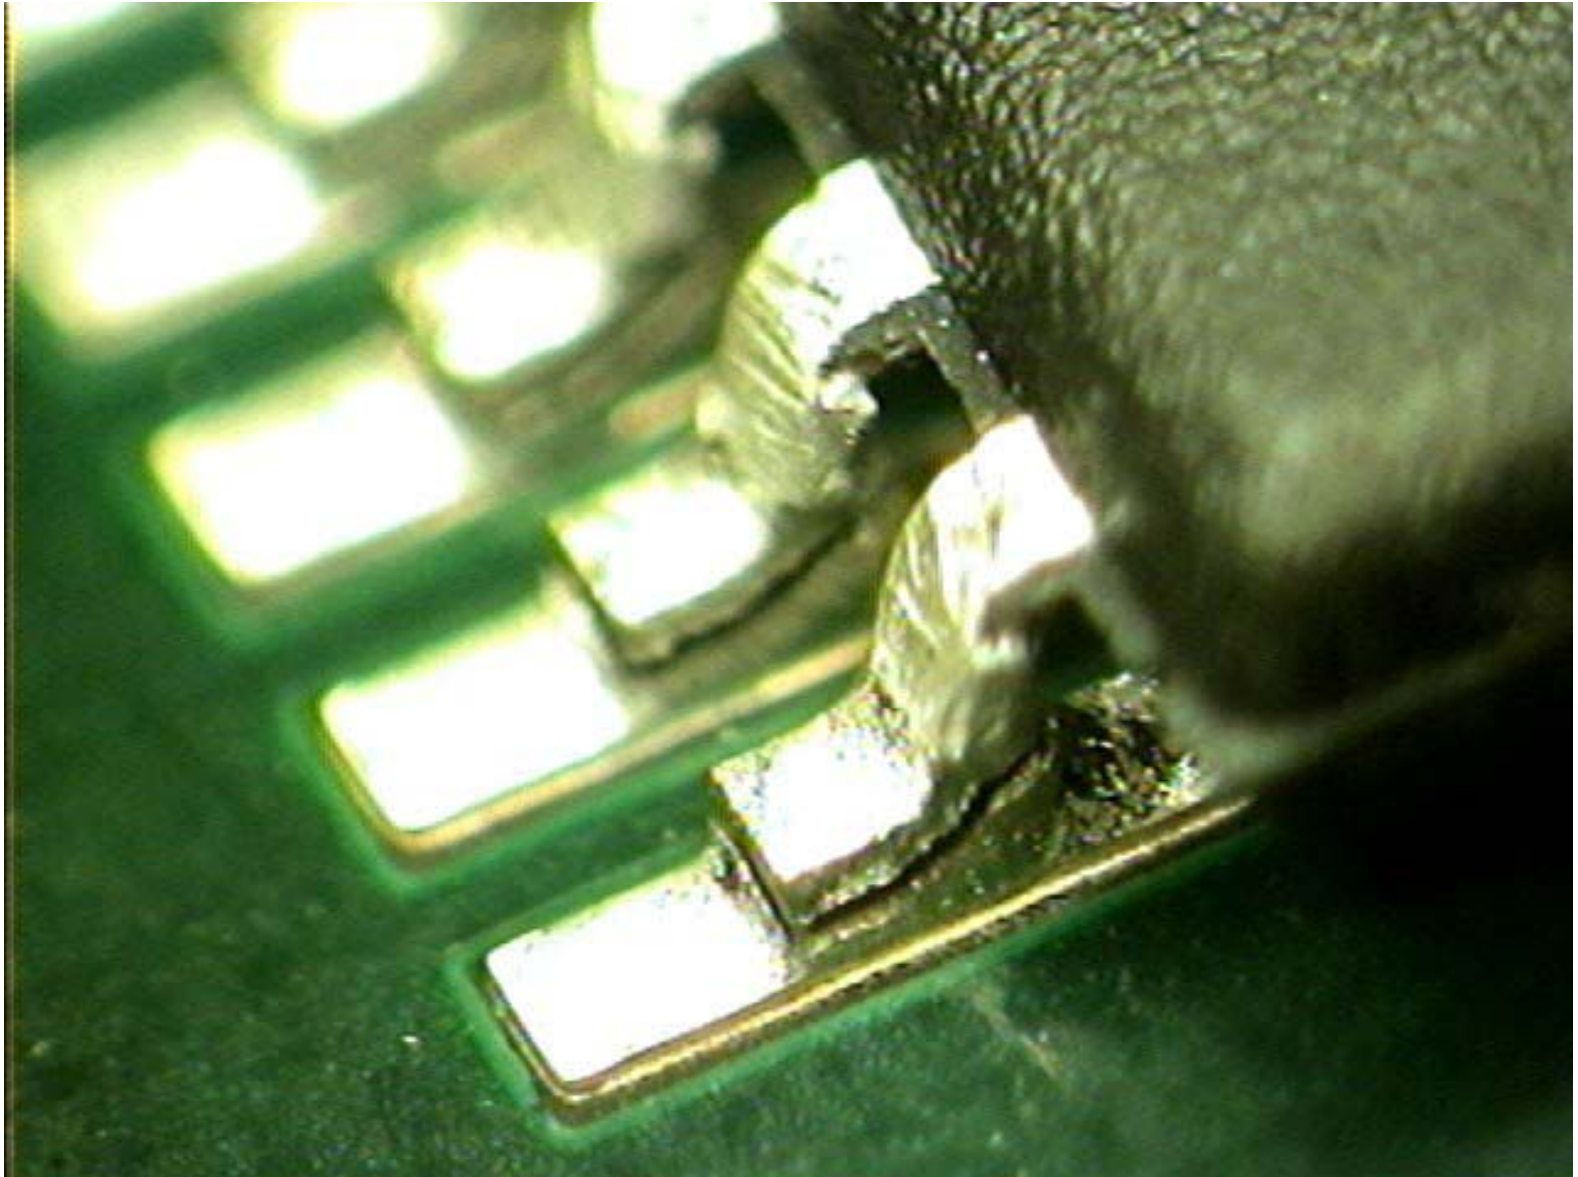
Typical TSOP Failure
